New LANCER LEV Portion Control replaces the TouchSensor Portion Control2
New LANCER EZ-Fill Valve Update3

Technical Bulletin Distribution:

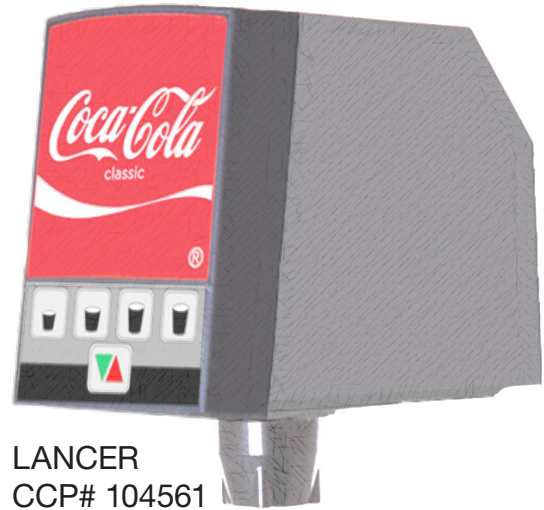
LANCER
CCP# 104561

There is a new LEV Touch Portion Control ID Panel that replaces the TouchSensor EasyTouch Portion Control ID Panels.

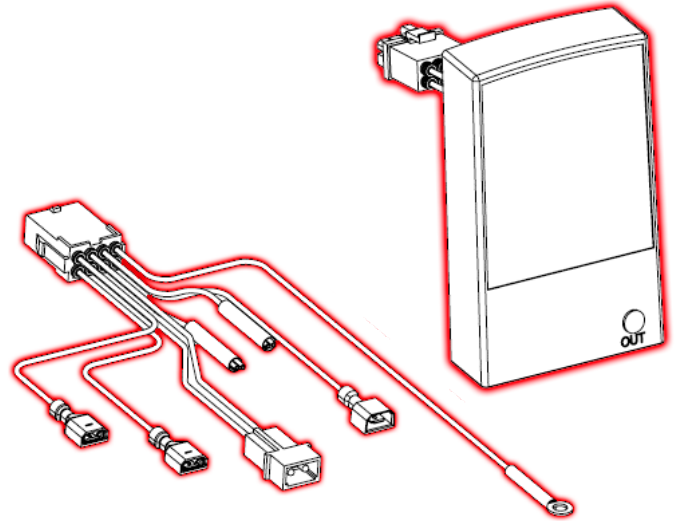
Lancer EZ-Fill valves were having issues with continuity causing the valves to remain in the on position and not shut off once activated.

Originally, a supplier discontinued the production of the conductive plastic resin that the bonnet was made of. We used that conductive resin to provide continuity throughout the flow stream, allowing there to be a complete circuit and triggering shut off when water touched the lever and the valve.

Once that plastic resin was discontinued, Lancer decided to move to a modified harness that will allow the ground to be placed on the facet plate and connect to the flow stream from the back block. This solution later caused issues where sometimes the circuit board would short out. Other times there were issues with having a proper ground and the valves would not shut off.

Lancer has decided to move back to using the bonnet, but instead of sourcing a conductive plastic resin, Lancer decided to use a stainless-steel bonnet. This will provide necessary continuity, remove the risk of shorting the circuit board, and allow for a consistent ground source.
