New LANCER LEV Portion Control replaces the TouchSensor Portion Control2
New LANCER EZ-Fill Valve Update3

Technical Bulletin Distribution:

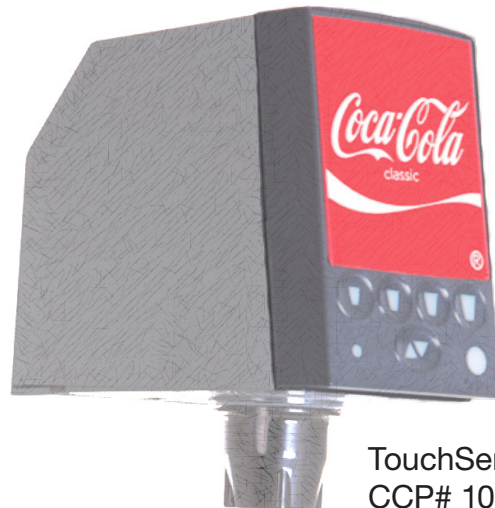
TouchSensor
CCP# 104561

There is a new LEV Touch Portion Control ID Panel that replaces the TouchSensor EasyTouch Portion Control ID Panels.

The enhanced capacitive touch buttons have a clean look and are more attractive than the EasyTouch portion control ID Panel.
